## SECURITY · MALAYSIA

## 358 Anti-Climb Security Fence for a Steep Hillside Facility

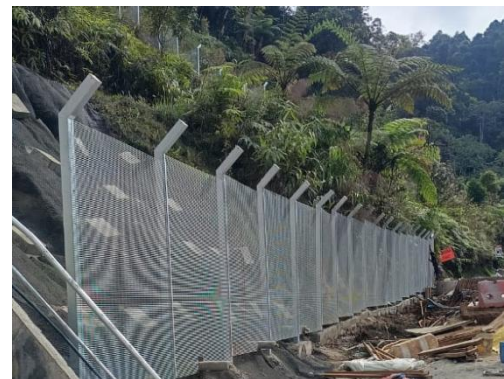
*Fence line following the slope*

Shengsen supplied 358 anti-climb mesh panels paired with matching posts fabricated to anchor directly into the concrete retaining wall footings, allowing the fence line to step cleanly down the slope alongside the wall. The line was topped with barbed wire and razor wire for an added layer of deterrence, and installed panel by panel as each wall section was completed.

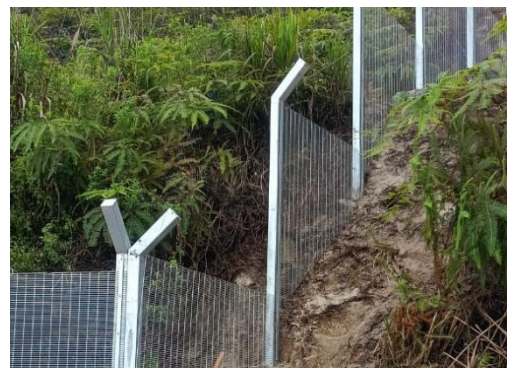
*Post and mesh installation detail*
